REPORT OF FINDINGS

101 SOUTHWIND COVE
BENTON, AR

Re: Report of Findings, Structural Investigation,
Benton, Arkansas,

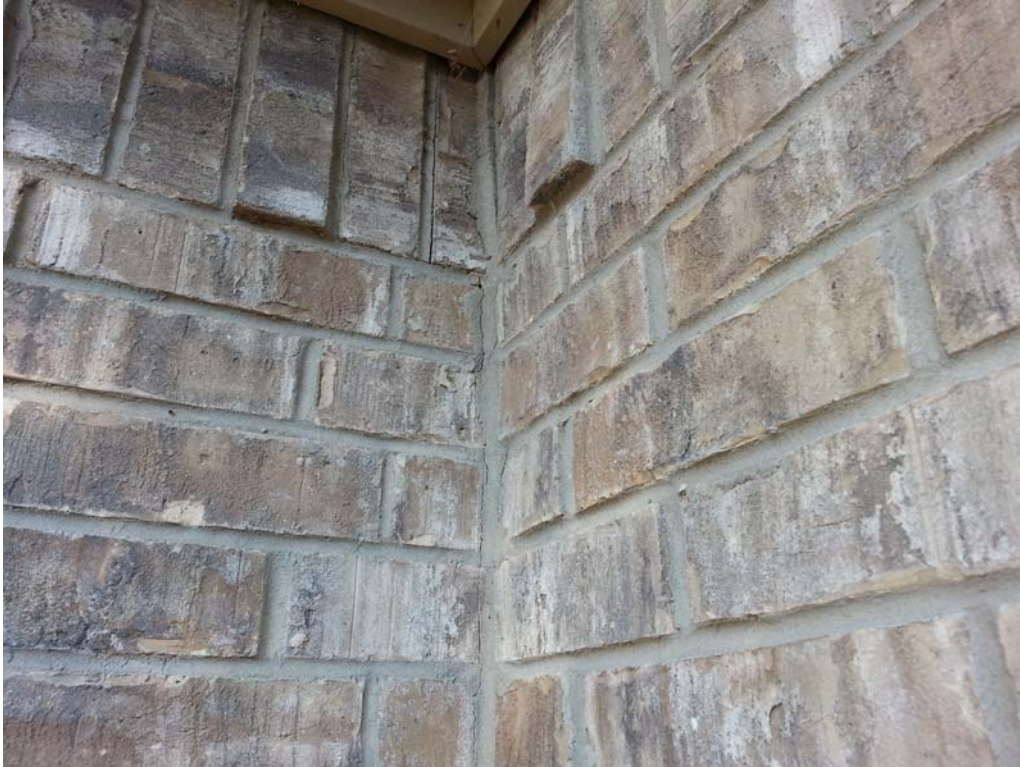
- Two tight cracks were observed in the upper half of the east wall. One is located near the interior corner and the second is located near the exterior corner.

It is my judgment that the foundation does not require any additional attention. The cracks in the interior and exterior walls appear to be due to the excavating and jacking of the foundation. The exterior cracks are closed cracks which indicates to me that the foundation is at its original elevation and stable., however, since this repair is so recent, and I didn't observe the repair procedure, I cannot guarantee that the foundation will not move.

Crack at interior corner of east wall.

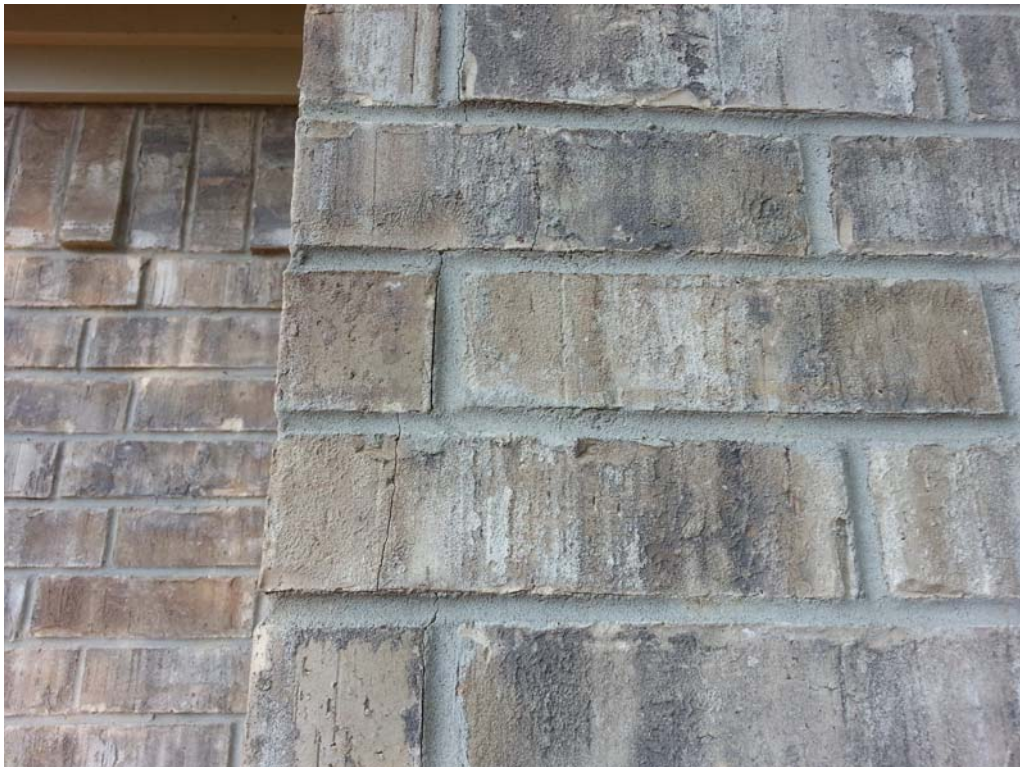
Crack at exterior corner of east wall.

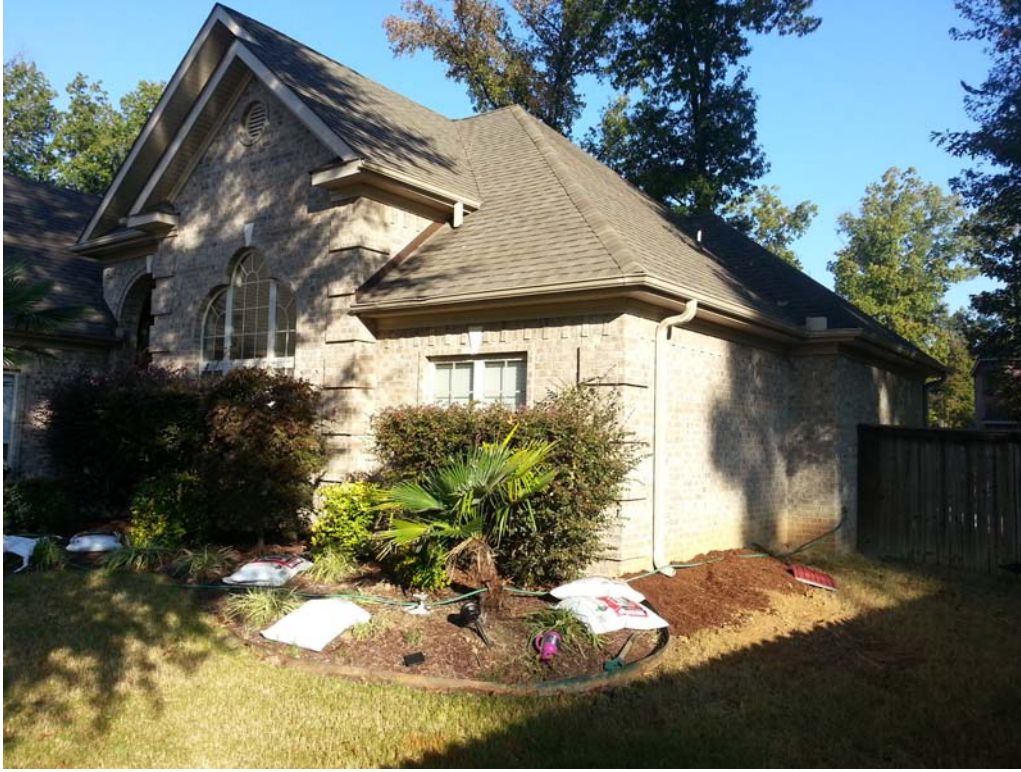
Location of the southeast foundation repair is to the right of this downspout.

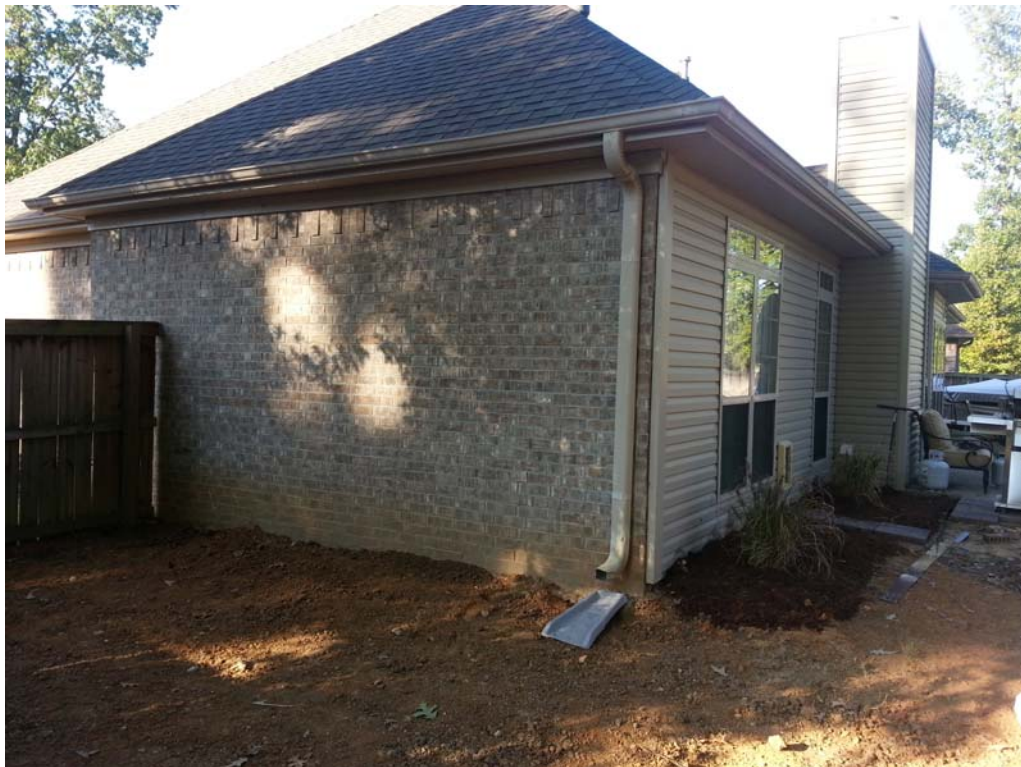
Location of the northeast foundation repair is to the left of this downspout.
